DEPARTMENT OF TRANSPORTATION**DIVISION OF ENGINEERING SERVICES**

Quality Assurance and Source Inspection

Contract #: 04-0120F4Cty: SF/ALA Rte: 80 PM: 13.2/13.9File #: 1.28**WELDING INSPECTION REPORT****Resident Engineer:** Casey, William**Address:** 333 Burma Road**City:** Oakland, CA 94607**Report No:** WIR-029082**Date Inspected:** 31-Jan-2013**Project Name:** SAS Superstructure**OSM Arrival Time:** 700**Prime Contractor:** American Bridge/Fluor Enterprises, a JV**OSM Departure Time:** 1730**Contractor:** American Bridge/Fluor Enterprises, a JV**Location:** Job Site**CWI Name:** See below.**CWI Present:** Yes No**Inspected CWI report:** Yes No N/A**Rod Oven in Use:** Yes No N/A**Electrode to specification:** Yes No N/A**Weld Procedures Followed:** Yes No N/A**Qualified Welders:** Yes No N/A**Verified Joint Fit-up:** Yes No N/A**Approved Drawings:** Yes No N/A**Approved WPS:** Yes No N/A**Delayed / Cancelled:** Yes No N/A**Bridge No:** 34-0006**Component:** Tower**Summary of Items Observed:**

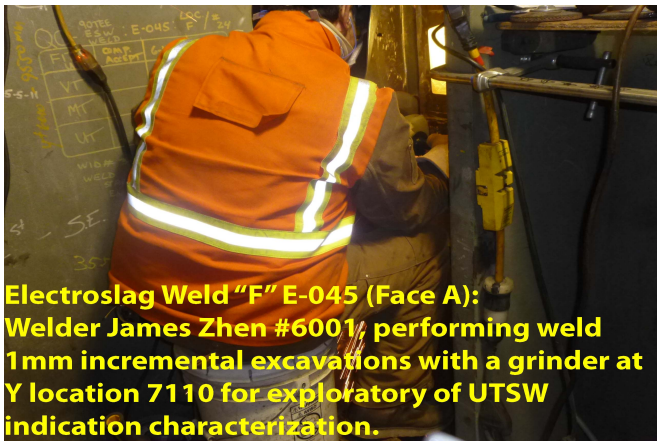
The welder was observed excavating the Electroslag Weld "F" E-045 at face A, in 1mm increments at the Y location 7110. Each of the 1mm excavation was performed with a grinder and was Magnetic Particle Tested (MPT) and photographed by QC Inspector Fred Michaels and this QA . The excavation continued at 36mm deep from the previous shift until a depth of 40mm at the end of the shift. This concluded the grinding excavation at this Y location, and the welder was observed relocating and setting up at another weld location. The welder was observed grinding the entire shift.

- 1mm incremental excavation at Y 7110 from 36 to 40mm deep. (MPT Reject)
- A TL-6028 is not required for this MPT.

Electroslag Weld "F" E-045 (Face A):
Welder James Zhen #6001, performing weld
1mm incremental excavations with a grinder at
Y location 7110 for exploratory of UTSW
indication characterization.

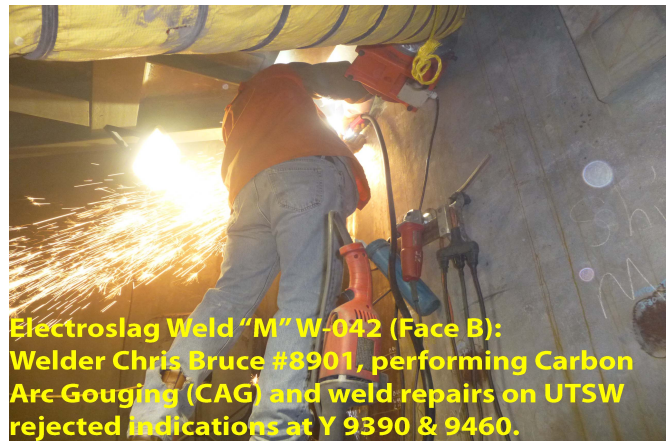
The welder was observed Carbon Arc Gouging (CAG) and performing the weld repairs on excavations on the Electroslag Weld "M" W-042 at face B. The indications were rejected with Ultrasonic Testing Shear Wave and were excavated at Y locations 9390 and 9460 as per Request for Weld Repairs or the RWR 201301-044 & 045. The welder was observed preheating the weld to 300 degrees Fahrenheit prior to welding using the Miller ProHeat 35 with heat induction blankets. The welder utilized the Welding Procedure Specification (WPS) ABF-WPS-D15-1000-Repair Rev.3 for Shield Metal Arc Welding (SMAW). The welding parameters were verified by QC Inspector William Sherwood throughout the day and they appeared to be in compliance with the WPS noted above.

Electroslag Weld "M" W-042 (Face B):
Welder Chris Bruce #8901, performing Carbon
Arc-Gouging (CAG) and weld repairs on UTSW
rejected indications at Y 9390 & 9460.

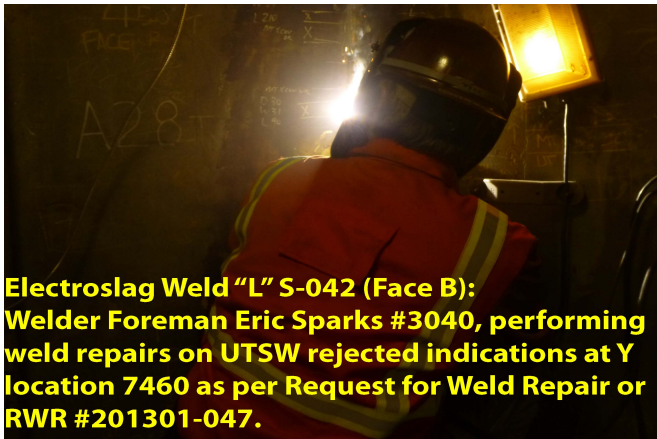
The welder was observed performing the weld repairs on excavations on the Electroslag Weld "L" S-042 at face B. The indication was rejected with Ultrasonic Testing Shear Wave and was excavated at Y location 7460 as per Request for Weld Repairs or the RWR 201301-047. The welder was observed preheating the weld to 300 degrees Fahrenheit prior to welding using the Miller ProHeat 35 with heat induction blankets. The welder utilized the Welding Procedure Specification (WPS) ABF-WPS-D15-1000-Repair Rev.3 for Shield Metal Arc Welding (SMAW). The welding parameters were verified by QC Inspector William Sherwood throughout the day and they

Electroslag Weld "L" S-042 (Face B):
Welder Foreman Eric Sparks #3040, performing
weld repairs on UTSW rejected indications at Y
location 7460 as per Request for Weld Repair or
RWR #201301-047.
